Manhole Inspection Summary

Manhole # S31SS_030MH

Insp Date: **5/10/07 11:18 AM**

Location Address: **2800 FOX ST**

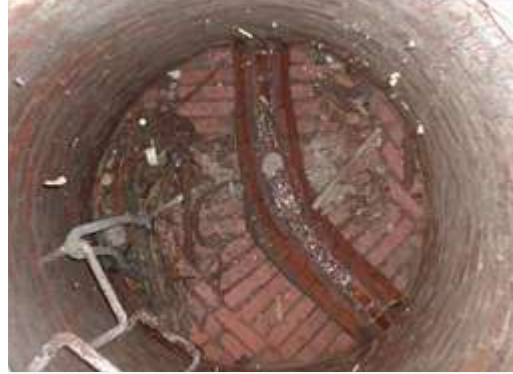
Top View

Corroded steps. Bench debris.

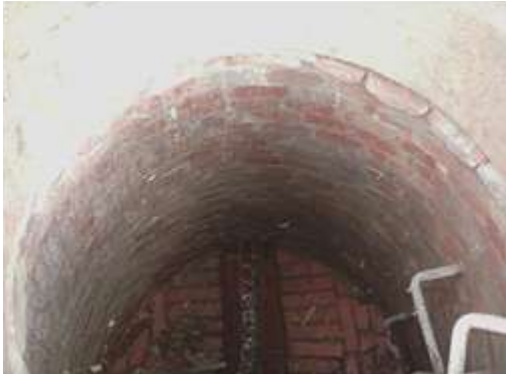
Defect

Frame leaks. Adjustment deterioration and infiltration. Barrel infiltration - other side.

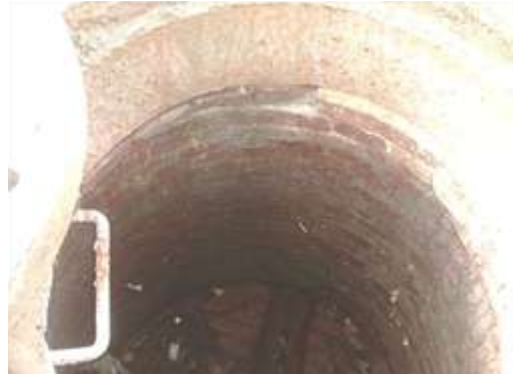
Defect

Frame leaks. Adjustment deterioration and infiltration. Barrel infiltration.

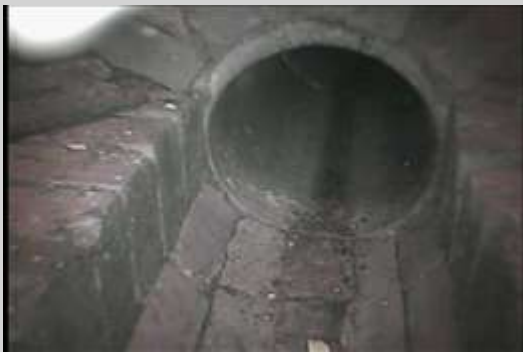
8 in. Circular Gravity Sewer Pipe Out @ 12 O'Clock

Infiltration: **None** Pipe Seal Cond: **Unknown**

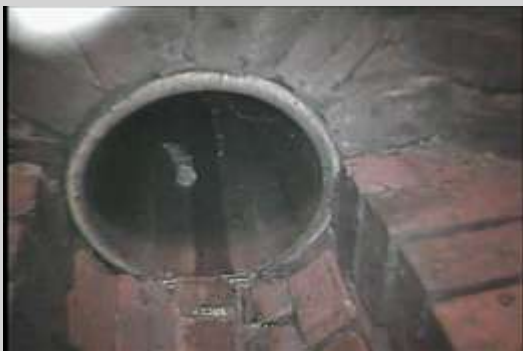
8 in. Circular Gravity Sewer Pipe In @ 5 O'Clock

Infiltration: **None** Pipe Seal Cond: **Unknown**
